2018 Data Report for Duck Lake, Muskegon County

Site ID: 610778

Duck Lake, Muskegon County 2018 CLMP Results

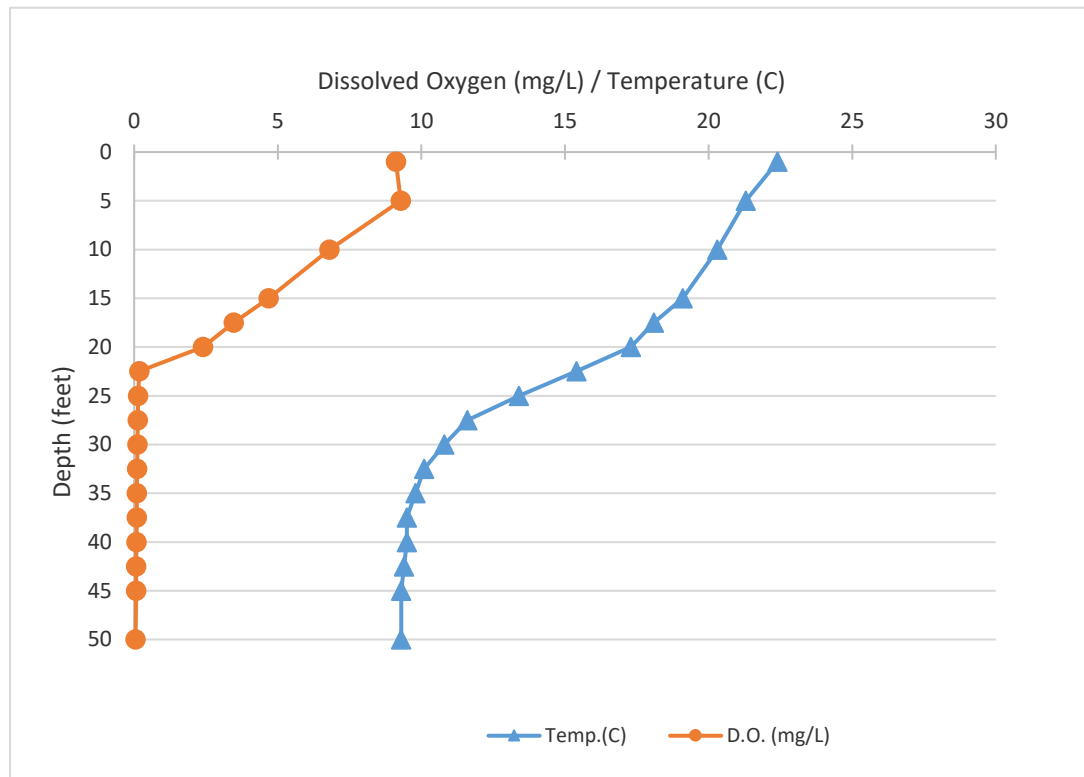
9/14/2018

Dissolved Oxygen and Temperature Profile

Depth (ft)	Temp.(C)	D.O. (mg/L)
1	22.4	9.12
5	21.3	9.28
10	20.3	6.8
15	19.1	4.68
17.5	18.1	3.47
20	17.3	2.4
22.5	15.4	0.18
25	13.4	0.14
27.5	11.6	0.13
30	10.8	0.11
32.5	10.1	0.1
35	9.8	0.09
37.5	9.5	0.09
40	9.5	0.08
42.5	9.4	0.07
45	9.3	0.07
50	9.3	0.05
